PWRs Operation and Maintenance

Feedwater Plant and Other Secondary Components – Mechanical Components

François Cattant

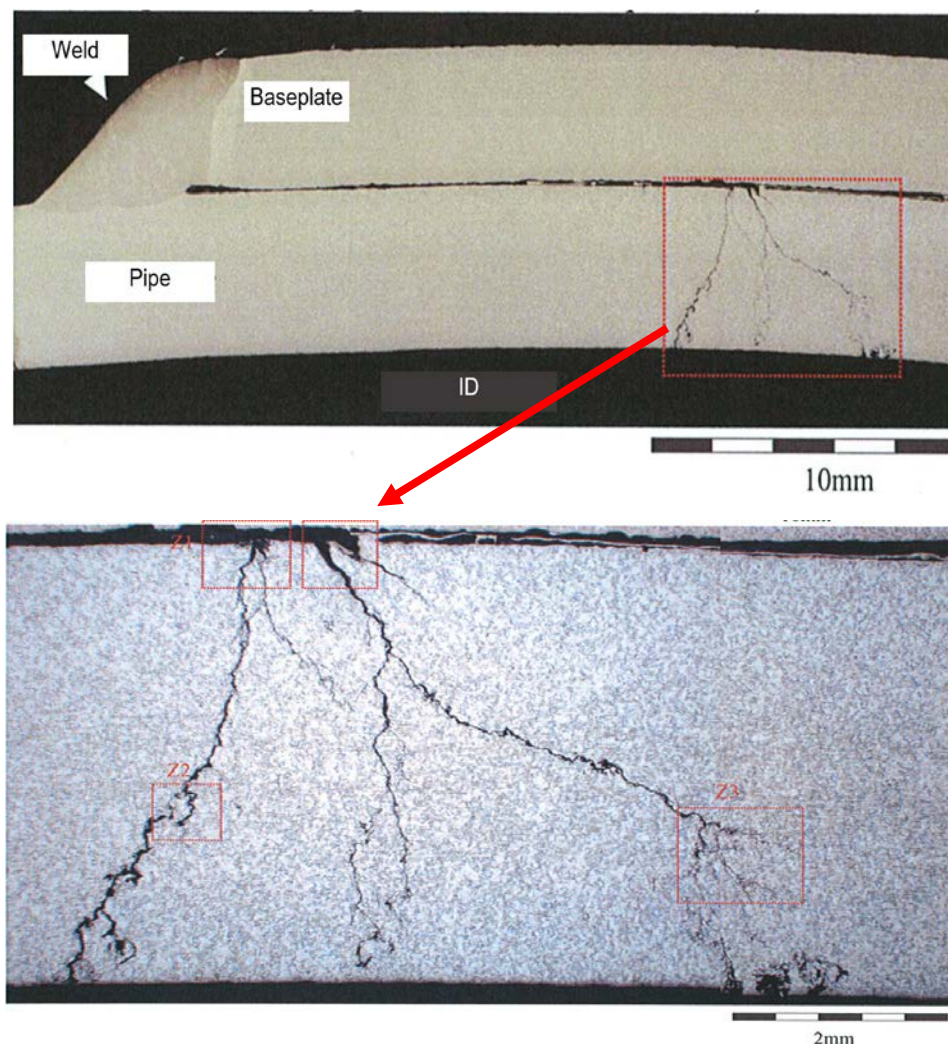
Corrosion below the water level line occurs into pipes where there is either a dual phase aerated environment or a stagnant liquid (situation for RCS auxiliary piping). Sometimes, we can also observe pitting corrosion either into low alloy steel or into stainless steel which can be passivated pipes. In this last situation, it is a concern rather for circuits which have been polluted by a deleterious specie. As regards stress corrosion cracking, it can be a concern for austenitic stainless-steel pipes wetted by primary water in areas where high residual stresses are present along with a highly cold worked material. However, stress corrosion cracking can rather occur in presence of high stresses along with an environment polluted with chlorides and/or sulphates. It has been observed into the RCS auxiliary piping, into dead legs between two valves, and into leak-off lines of valve packing and also on some welded base plates of pipes supports (observed into the reactor cavity and spent fuel pit cooling and treatment system at one unit and into the containment spray system at another unit (Figure 5-1)).

Figure 5-1: SCC observed into a containment spray pipe made of 304L: cracks have initiated at the pipe OD, from pits initiated into the gap between the welded base plate and the pipe (oxygenated environment polluted with chlorides) [Hutin, 2016].

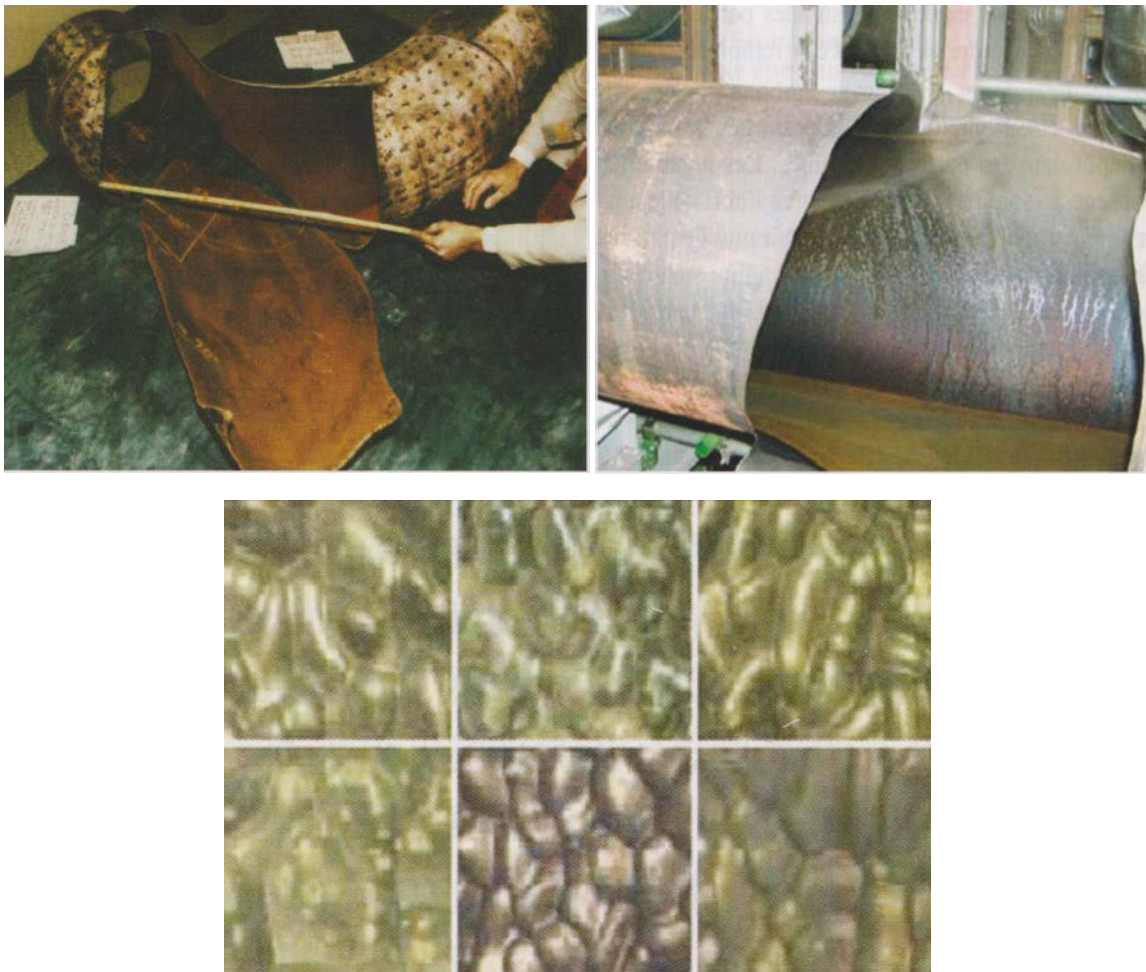
However, the most worrying failure mechanism is the flow assisted corrosion of carbon steel pipes. Why is this so worrying? Because this failure mechanism translates in a general wall thinning over a large surface which can eventually end up in pipe burst, without any preceding leak that could warn the operator something wrong is going on. Furthermore, as this thinning can occur in pipe free span, non-destructive examination cannot be of a major help as generally targeting welds, fittings and other similar exceptions. Because of this at Surry, on a steam generator feedwater pipe (upstream the turbine driven feedwater pump), an eighteen inches diameter and half inch thick elbow has literally exploded, being torn over a meter long and killing four people (Figure 5-2). It is also flow assisted corrosion which is responsible for the burst of a 560 mm diameter straight pipe located downstream low pressure reheaters, after 21 years of operation at Mihama (Figure 5-2). The residual thickness of the relevant pipe was 1.4 mm for an initial thickness of 10 mm and nothing alerted the operator; more than 200 persons were working in the turbine hall at this time to prepare the coming outage, five of them were killed.

Figure 5-2: View of bursts of feedwater pipes at Surry (top left) and Mihama (top right) following flow assisted corrosion wall thinning mechanism. Bottom: typical aspect of flow assisted corrosion ID features [Hutin, 2016].

Operators should keep in mind the parameters governing flow assisted corrosion: the steel chromium content, the temperature, the water pH, the steam quality if dual phase and the fluid velocity.

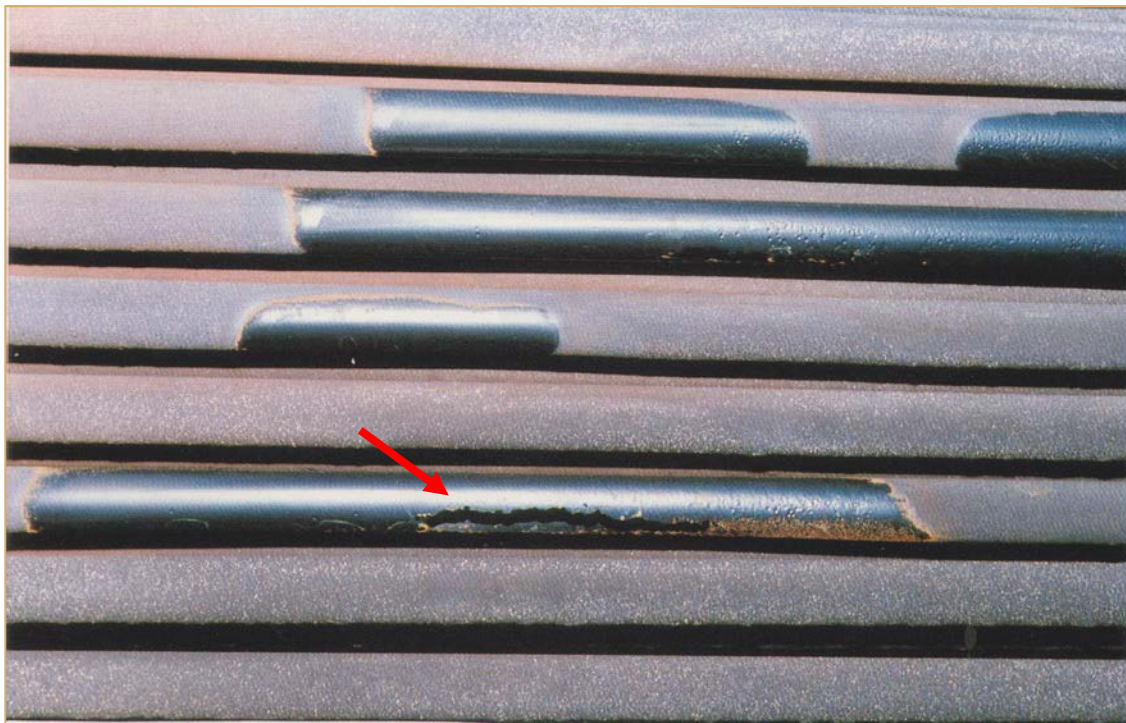
Results: The tubes are covered with a dark-grey deposit, with a crystal-like aspect, containing magnetite (Fe_3O_4). Smooth and bright areas are visible here and there, sometimes extending on several dozens of centimetres which correspond to surfaces that have been damaged by erosion-corrosion (Figure A-1). This damage, when very severe, can be through-wall. The support plates located upstream side on the steam circuit, present many joined small cavities which look like a shot-peened surface (Figure A-2 and Figure A-3). These damages are also from corrosion-erosion.

Figure A-1: The tube bundle exhibits here and there, smooth and oxide-free surfaces, made thinner by corrosion-erosion up to through-wall (red arrow) at some places [Mousset, 1990].

Remedial actions: A morpholine conditioning instead of an ammonia conditioning would probably have postponed the degradations, however, carbon steel tubes in contact with a water-steam mixture at high temperature are doomed to fail by corrosion in the long term. Carbon steel tubes should be replaced with austenitic stainless-steel tubes like AISI 304L (AFNOR Z2 CN 18-10).

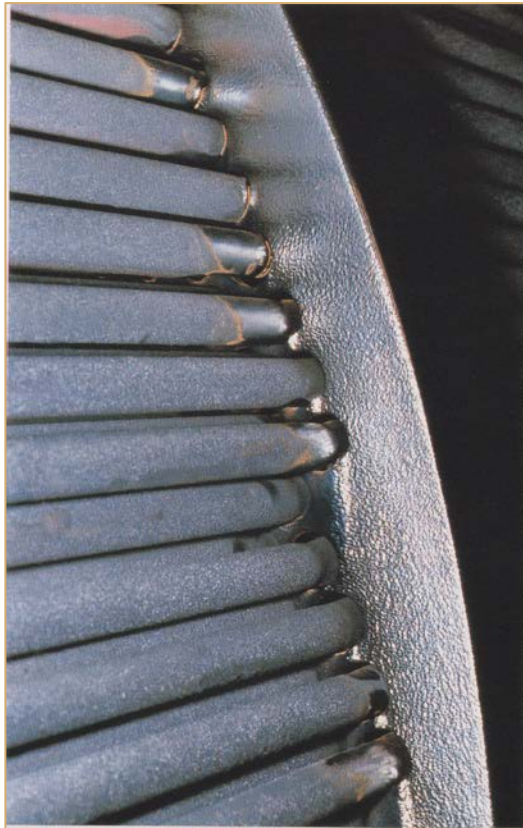
Figure A-2: View of damage to tube support plates and to tubes in the vicinity [Mousset, 1990].

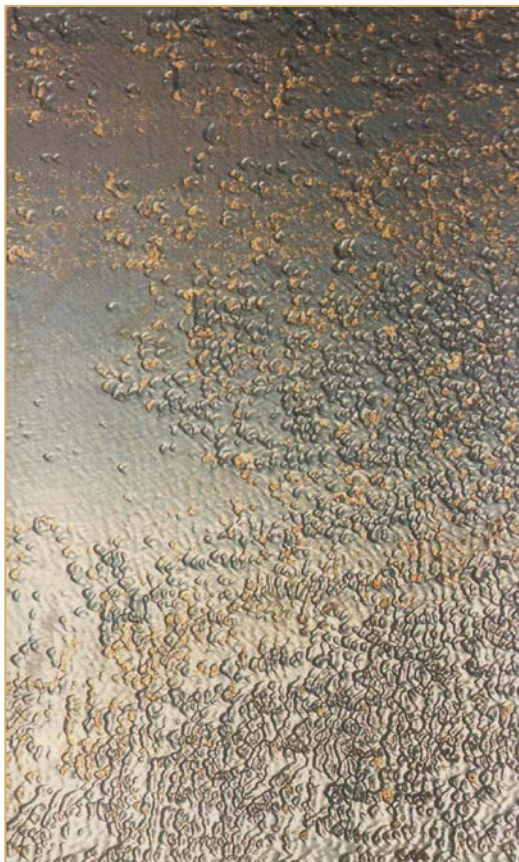
Figure A-3: The shot-peened aspect of the surface of the tube support plates results from corrosion-erosion [Mousset, 1990].

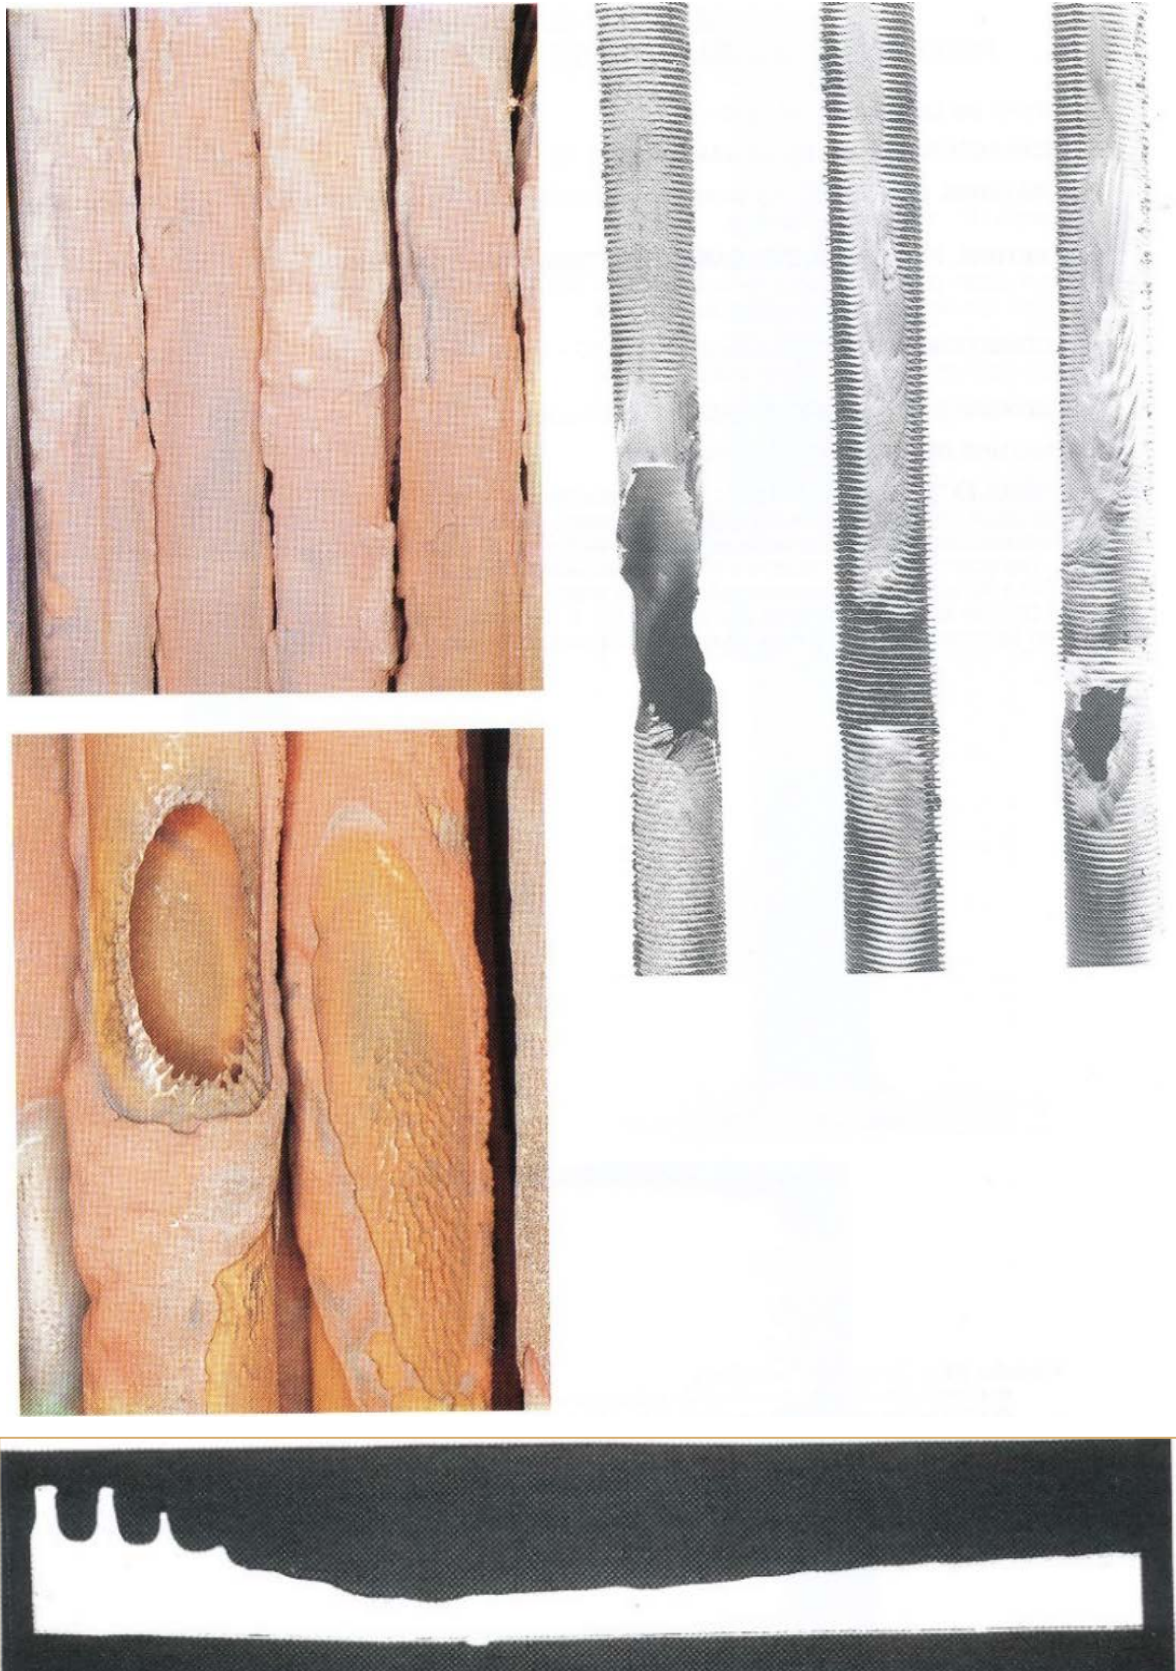
The tubes' end damages are due to a lack of tightness of the last tube spacer plate, inducing some wet steam jet.

Figure B-1: Top left: iron oxides deposits covering the tubes' end. Bottom left: end of the lower tubes at the periphery showing through wall erosion. Top right: area damaged by local corrosion-erosion, then by erosion close to a tube spacer plate. Bottom: axial cut of a zone damaged by corrosion-erosion [Mousset, 1990].

Conclusion and remedial action: In order to avoid the wet steam by-pass, the vendor has installed, between the last two tube spacer plates, an overlapping gasket and a drilled plate inducing an extra pressure drop limiting the steam jet velocity directed towards the bundle end.

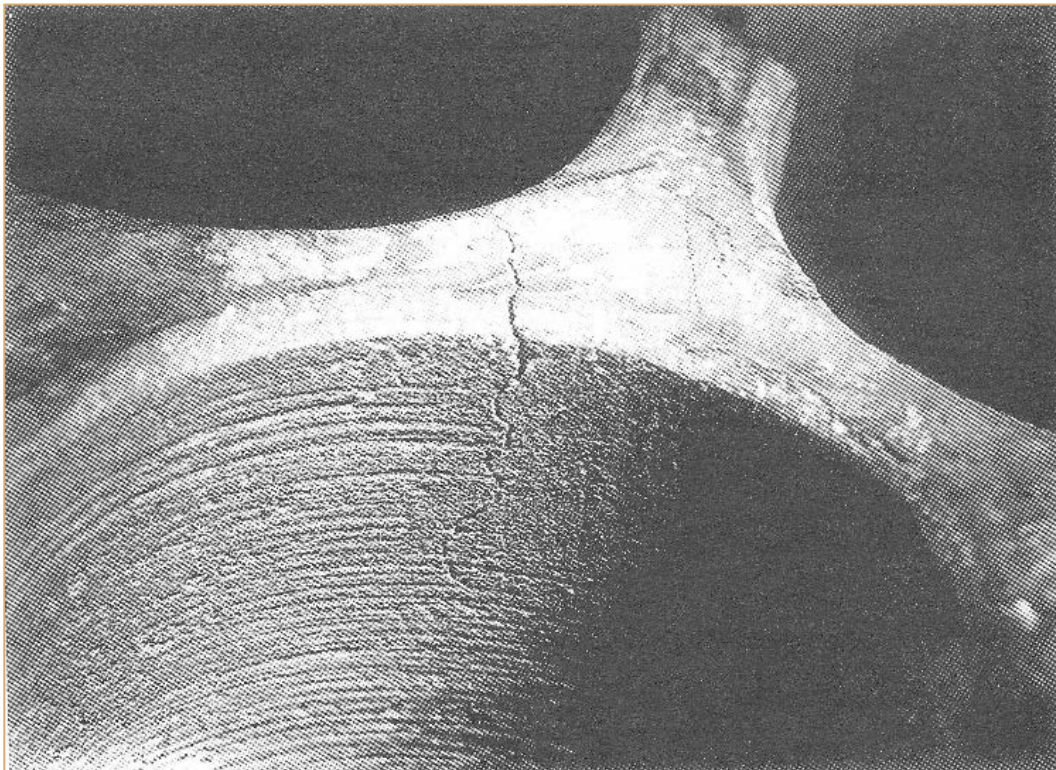
Failure discovery: When repairing the tube bundle, the workers discovered cracks on the last tube spacer plate (Figure B-2).

Figure B-2: View of tube spacer plate cracking [Mousset, 1990].

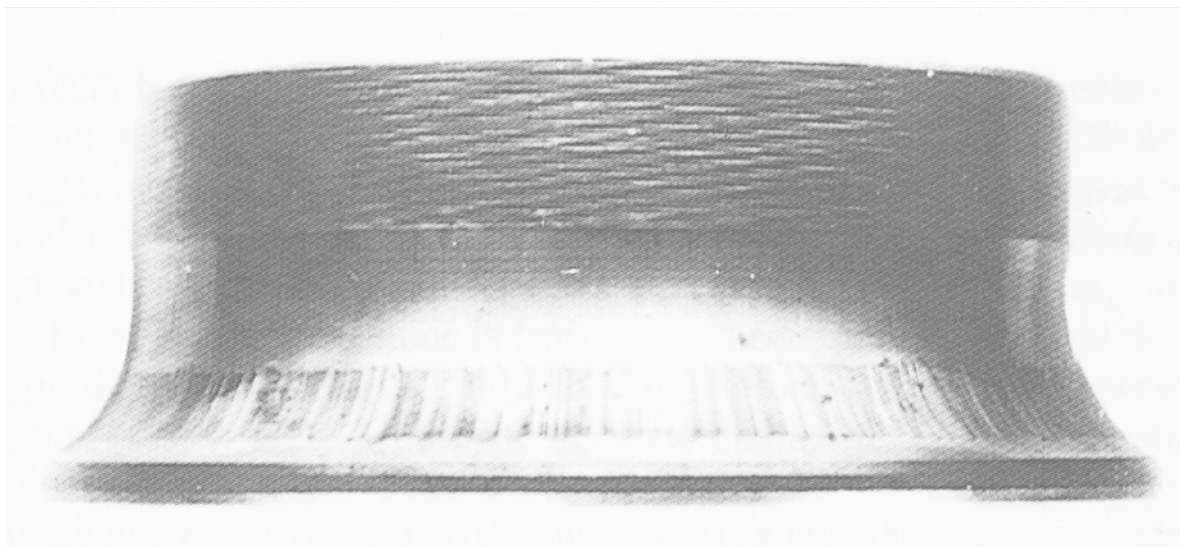
Figure C-1: View of the grooves on the lower track of a bearing [Mousset, 1990].

Remedial action: The remedial action consists in breaking the current flow by inserting an isolating ring into the bearings.

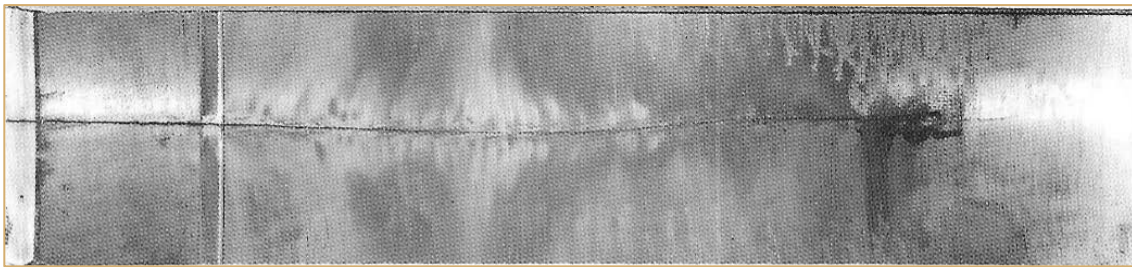
Results: The sleeve, free side of the pump (opposite side to the control), exhibits a through wall axial crack, around 200 mm (7.87") long at the sleeve OD. This crack is slightly longer at the ID (203 mm) (7.99") (Figure D-1). The crack initiated at the ID bevel location, in the shrunk zone in contact with the pump shaft shoulder. In this area, the crack, once broken open, exhibits a lunula with a fine grain, around a corrosion pit (Figure D-2). The remaining crack surface presents a coarser aspect, with lines-like marks calling for a quick propagation. Other corrosion pits are visible on the bevel, where the crack initiated (Figure D-3). SEM examination of the initiation area reveals an intergranular surface, consistent with a stress corrosion cracking phenomenon. Beyond, a semi-brittle shearing with a mix of inter and trans granular surface is visible. The mechanical properties of the sleeve material, are very high (UTS = 1400 MPa/203 KSI). A microprobe analysis carried out into an intergranular cracks network located at the bottom of a pit reveals the presence of sulphur, chlorine and calcium (Figure D-4).

Figure D-1: View of the sleeve ID cracking [Mousset, 1990].

Conclusion and remedial actions: The sleeve cracked from SCC because of its very high mechanical properties. Using a material with such high mechanical properties in contact with water is inappropriate.

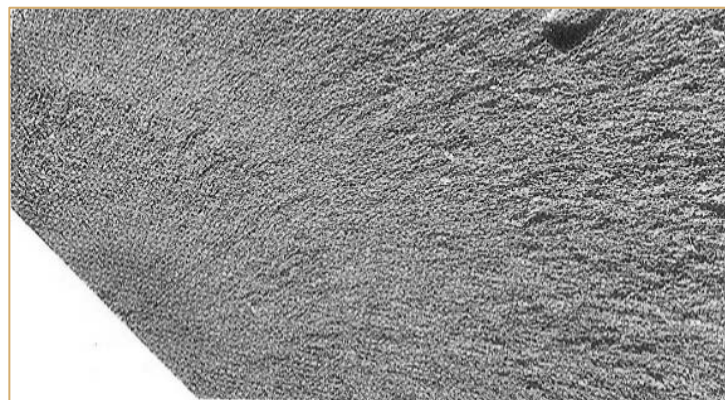
Figure D-2: Detail of the initiation zone where a dark lunula has been observed. Beyond, a first propagation zone is visible [Mousset, 1990]

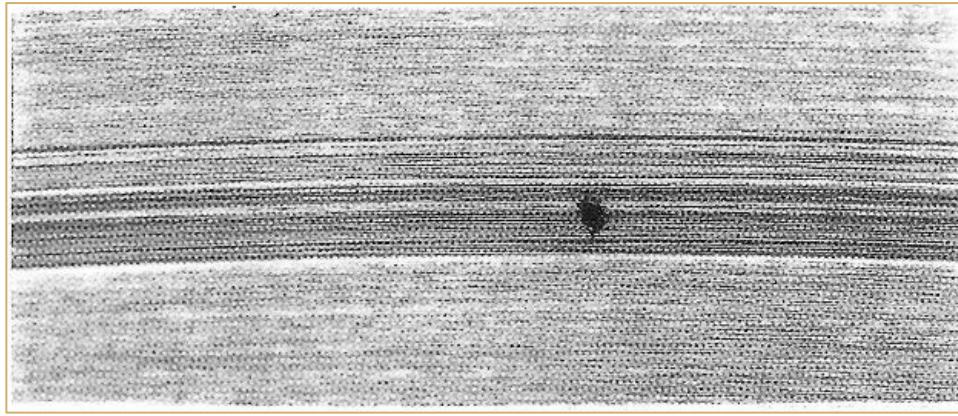
Figure D-3: View of the ID bevel where cracking initiated. Some coarse machining marks along with corrosion pits are visible [Mousset, 1990].

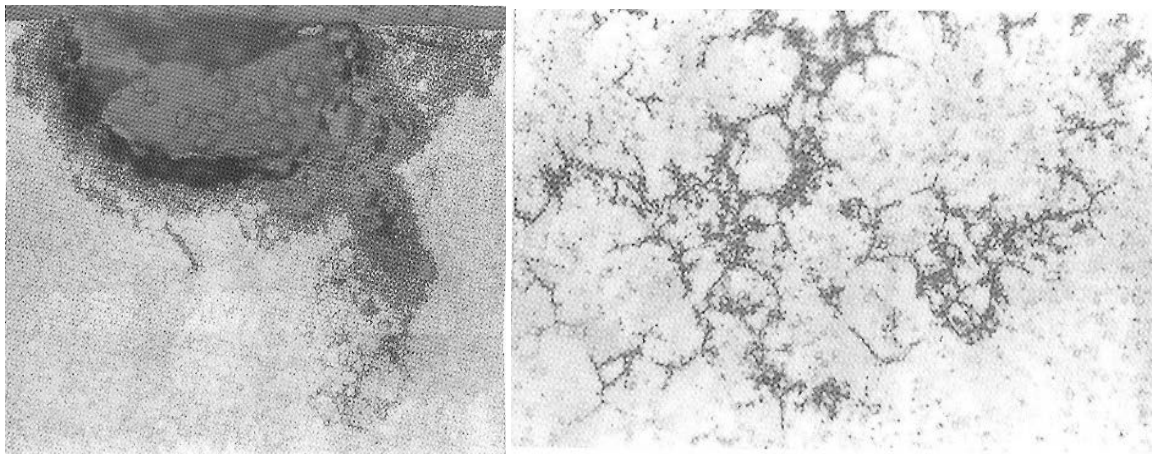
Figure D-4: Left: section micrograph of one pit. An intergranular crack network has initiated at the bottom. Right: crack network detail [Mousset, 1990].

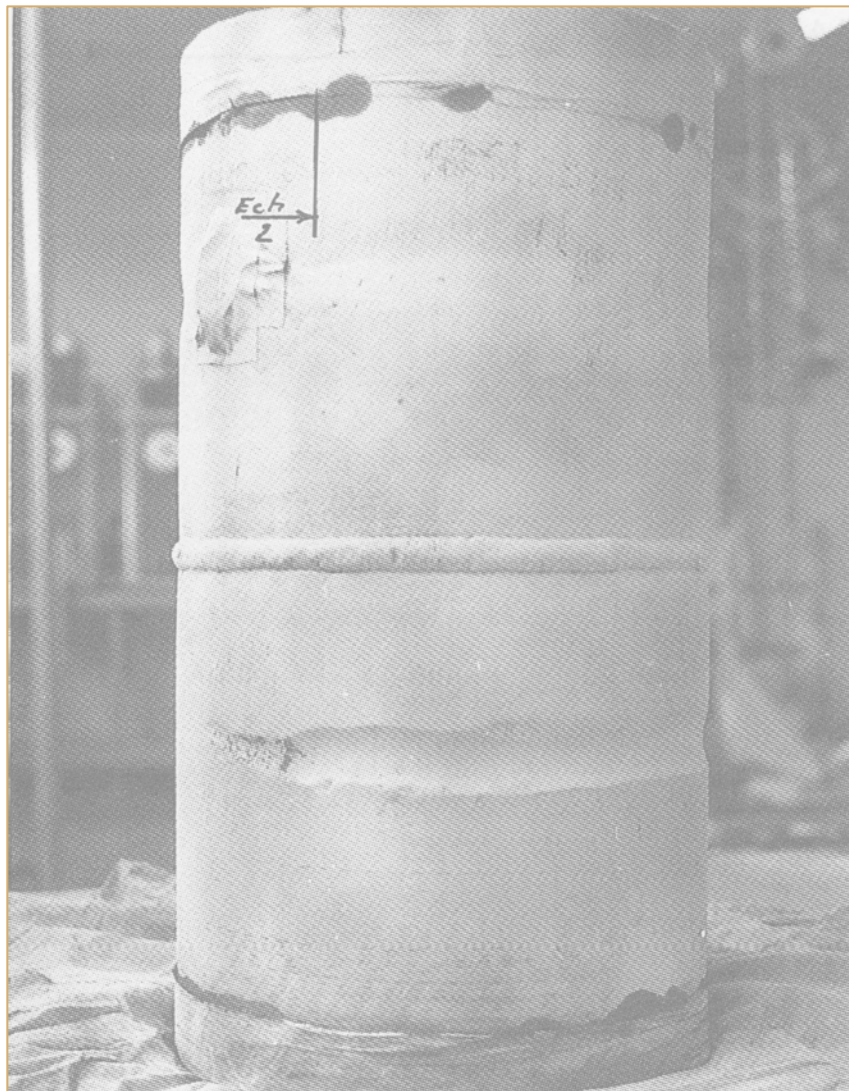
Failure discovery: In operation, a crack was observed on the pipe OD (Figure E-1).

Figure E-1: Cracked pipe segment exhibiting a transverse ground area [Mousset, 1990].

Conclusion, remedial actions: The products containing chlorine or sulphur should be strictly forbidden when in contact with austenitic stainless-steel.

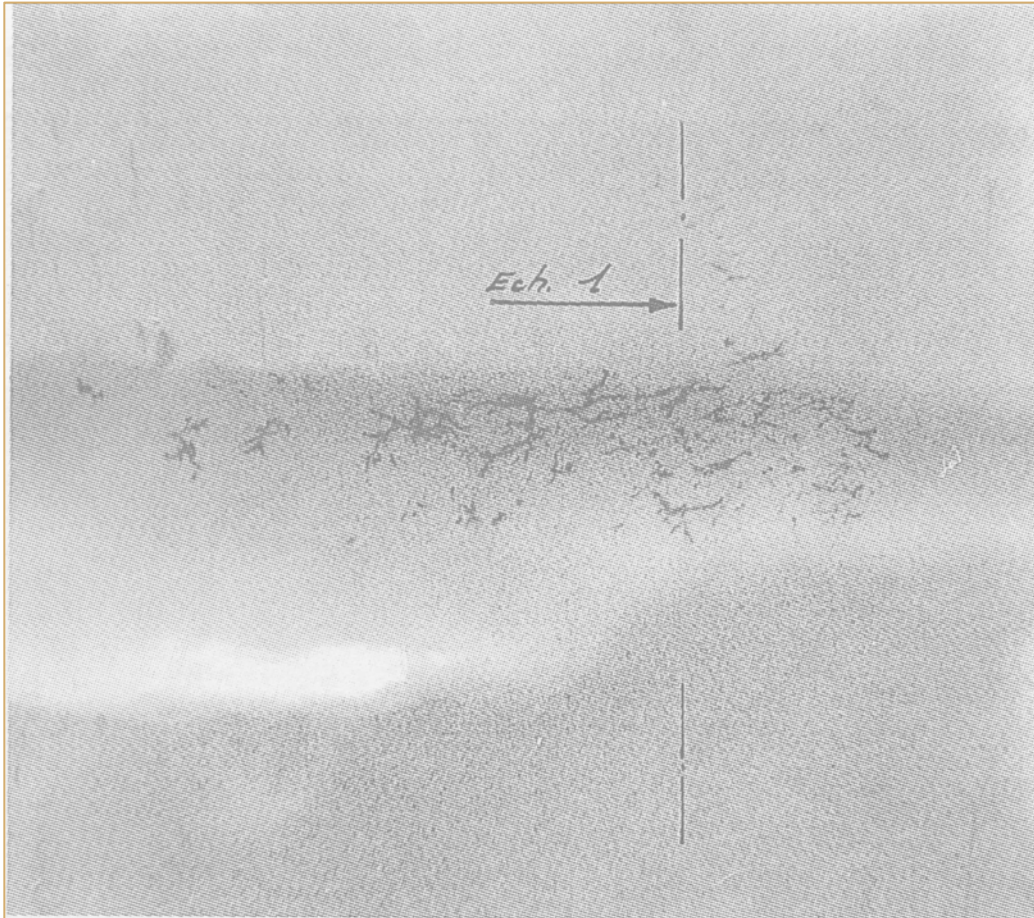
Results: A network of SCC cracks has been observed at the OD of the RHR pipe (Figure E-2). This cracking takes place in a circumferential band, at the location of the tape used as datum during installation. The cracks are very branched and trans granular (Figure E-3 and Figure E-4).

Micro-analysis reveals the cracks oxides contain a high chlorine ratio. Some cracks are half through-wall. The chlorine polluted oxides found into the cracks likely stem from the thermal decomposition of PVC bands. The condensation of the room humidity allowed the generation of an electrolyte. The internal stresses result, depending on the location, of the forming or welding processes, and on the installation of the pipe.

Figure E-2: Crack network observed after PT at the tip of the ground area [Mousset, 1990].

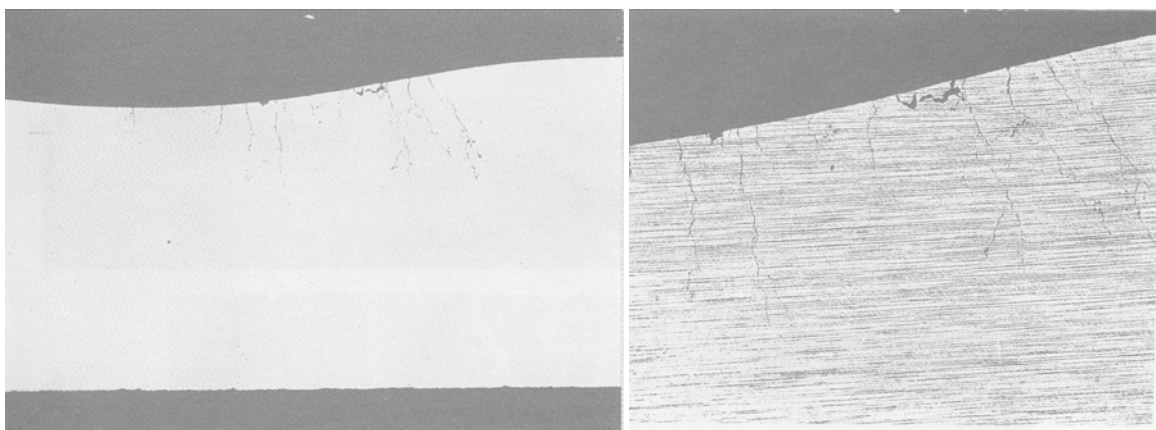
Figure E-3: Left: cross section showing the cracks 'propagation in the bottom of the ground area (x5.9). Right: view at higher magnification (x12.2) [Mousset, 1990].

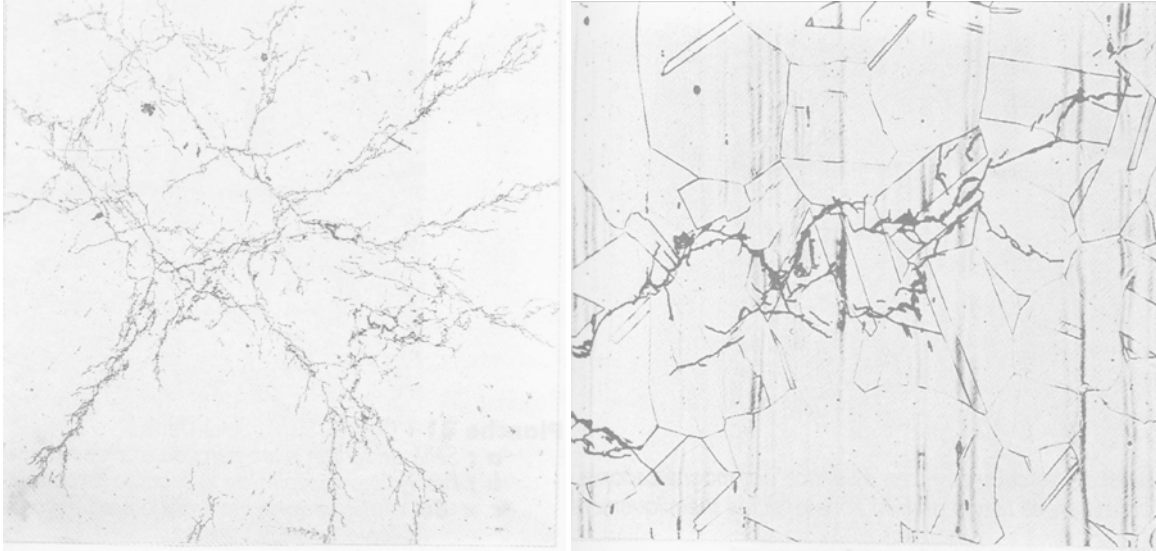
Figure E-4: Left: replica taken in a cracked area showing a dense network of all-directions cracks (x52). Right: after chemical etch, the cracks appear as branched and trans granular (x230) [Mousset, 1990].

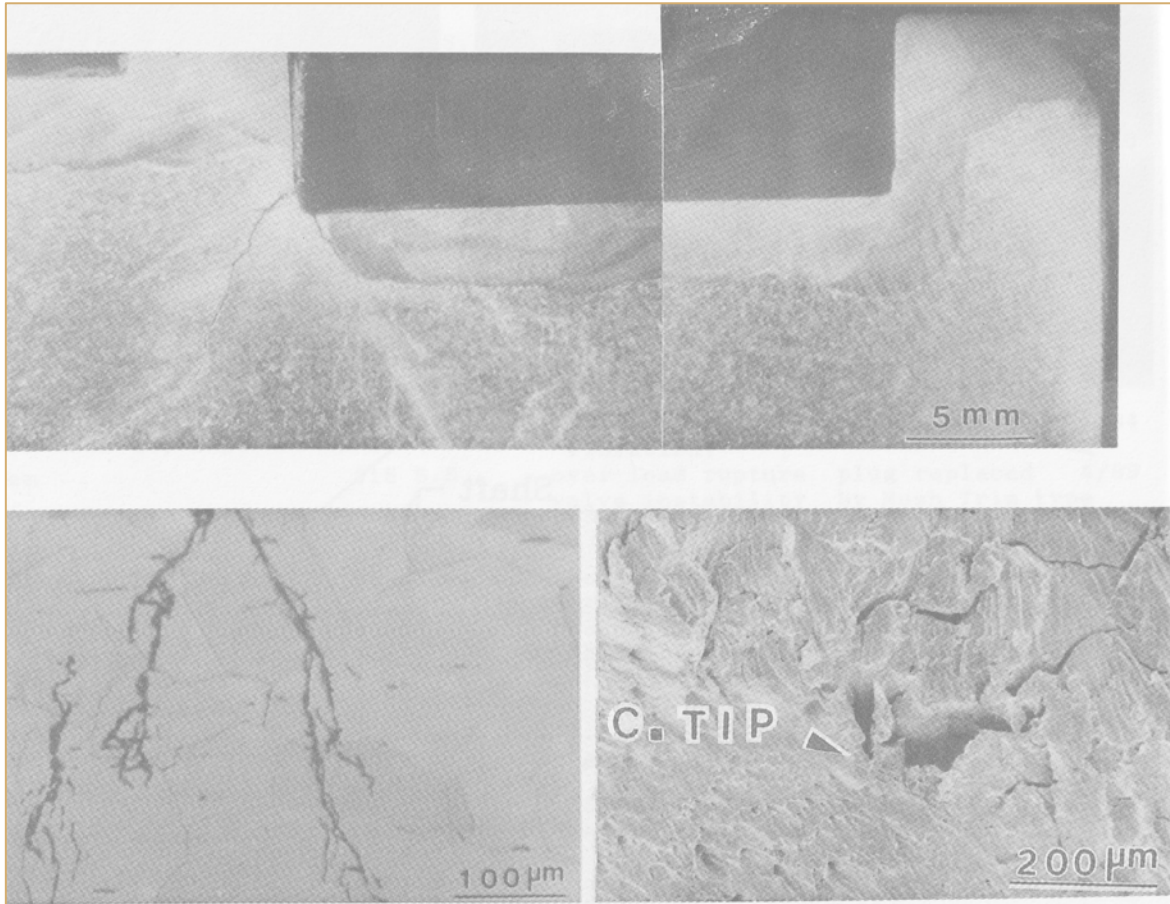
Figure F-2: TGSCC cracks initiated at the stellite free surface of the feedwater bypass flow valve plug [Lai et al, 1990].

The careful inspection of the plug dimensions, of the cladding process and of the final machining during the manufacture process is proposed as remedial actions.

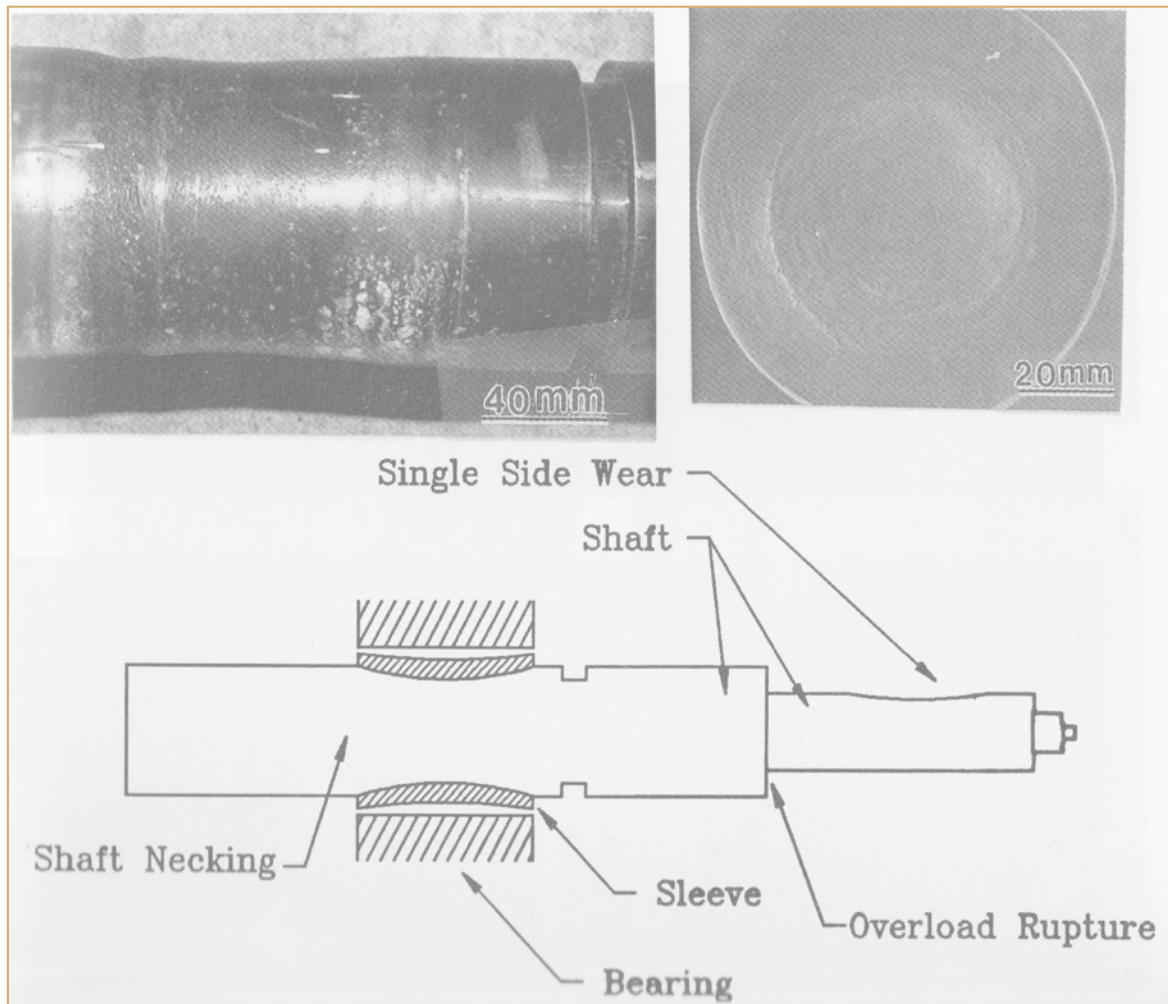
The root cause of one shaft failure was due to a lack of lubrication caused by the rupture of the lube pipe (schedule 80 carbon steel), and the other shaft rupture was due to long operation at low flow rate.

Figure G-2: View of the broken shaft and presentation of the hypothetical failure process with abnormal wear [Lai et al, 1990].

As remedial actions, it was suggested to replace the lube pipe with a schedule 160 carbon steel pipe coupled with a supporting plate, and to install a low flow rate time delay trip.

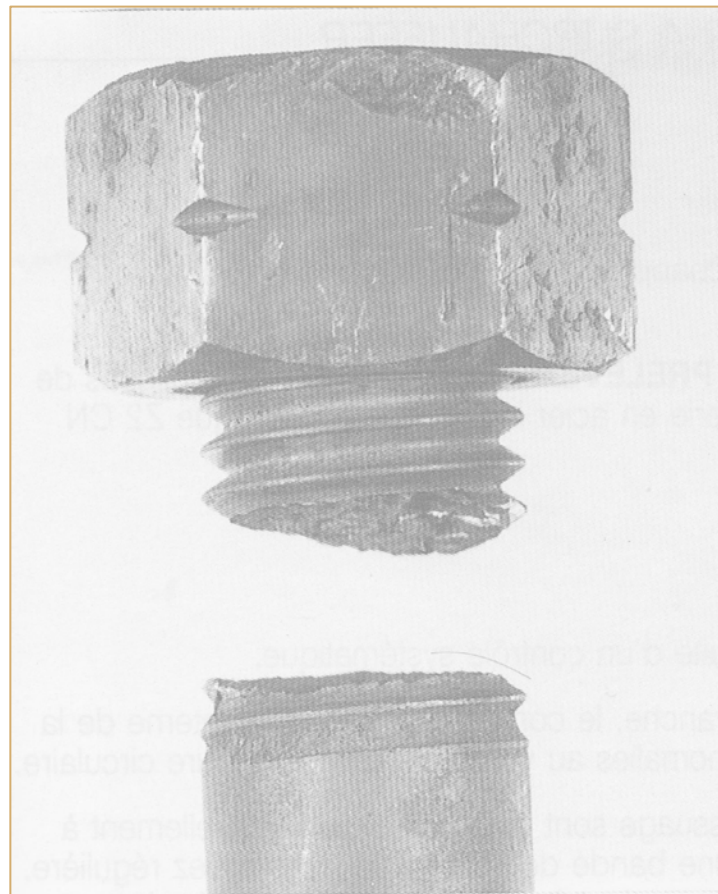
Results: The ruptures occurred at the bottom of the threads and are not tie to any deformation of the stud (Figure H-1).

Figure H-1: View of a broken stud, no deformation is visible in the thread bottom [Mousset, 1990].

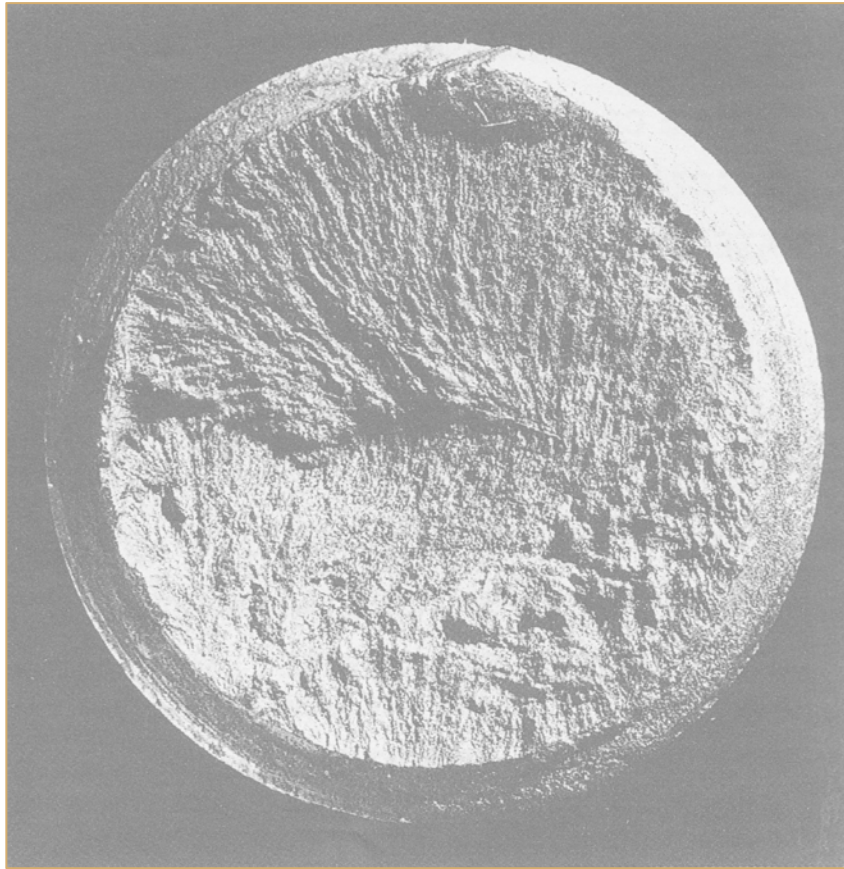
They exhibit a brittle aspect and radiate from peripheric initiation sites (Figure H-2). These initiation sites correspond to very small pits.

Figure H-2: Rupture by stress corrosion cracking propagating from peripheric initiation sites [Mousset, 1990].

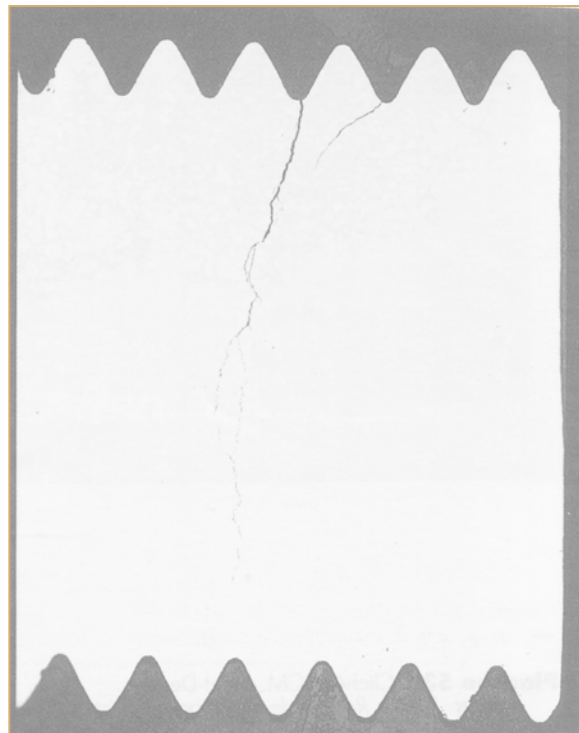
Axial sections reveal the presence of other branched and trans granular cracks (Figure H-3), initiated in the bottom of the threads (Figure H-4).

Figure H-3: Branched cracking observed on an axial section of a stud [Mousset, 1990].

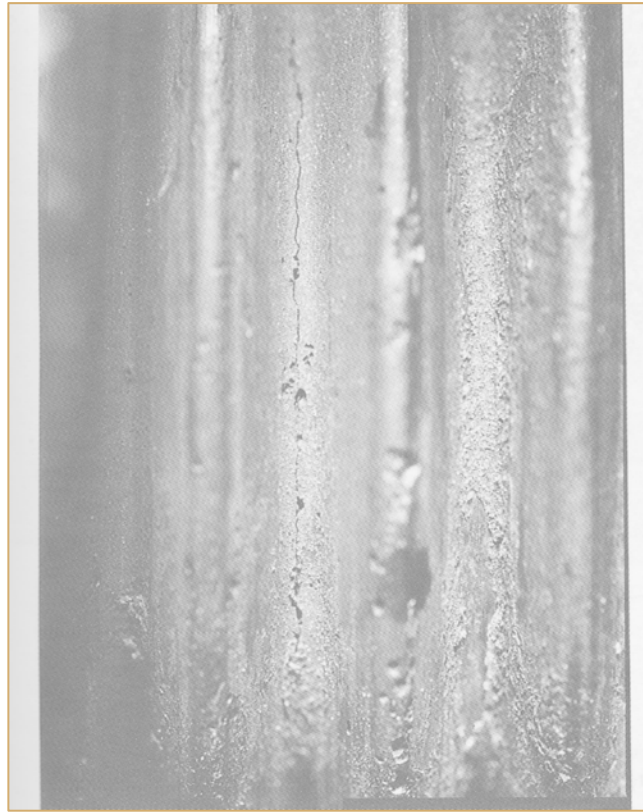
Figure H-4: Visual examination of a crack located in the bottom of a thread [Mousset, 1990].

Microanalysis conducted with a microprobe, allowed the detection of a sulphur pollution into the cracks. This element likely stems from the thermal decomposition of the grease containing molybdenum disulphide (MoS_2). This grease was often used during the installation of valves.
