Key Emerging Issues and Recent Progress related to Structural Materials Degradation

A.N.T. INTERNATIONAL®

© December 2017

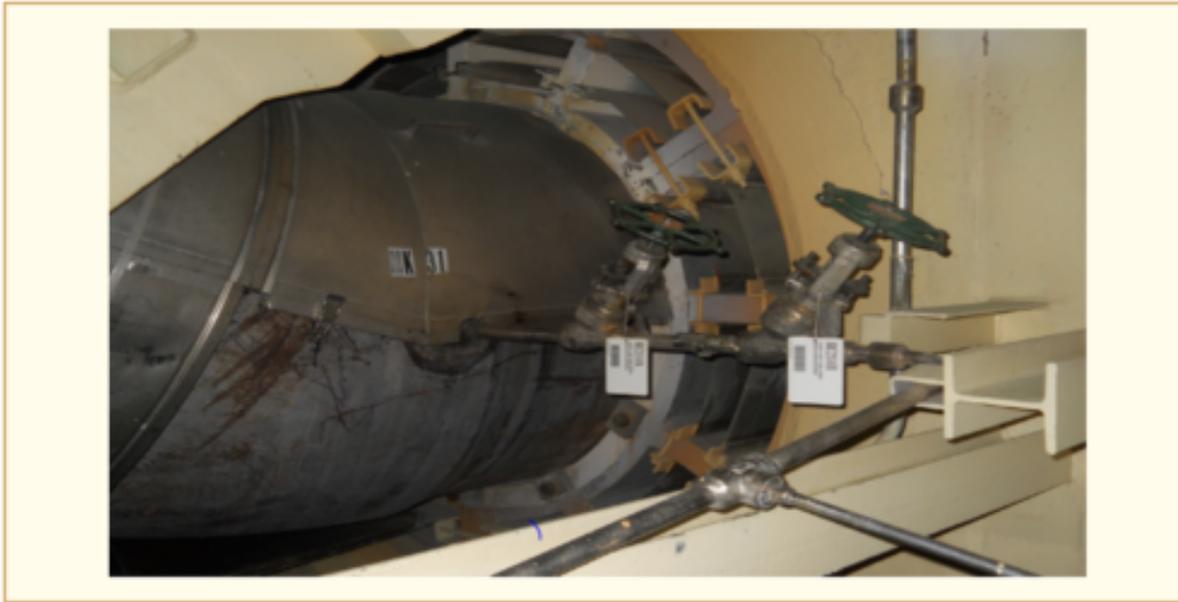
Figure 6-2: Typical branch connection [Waskey, 2016].

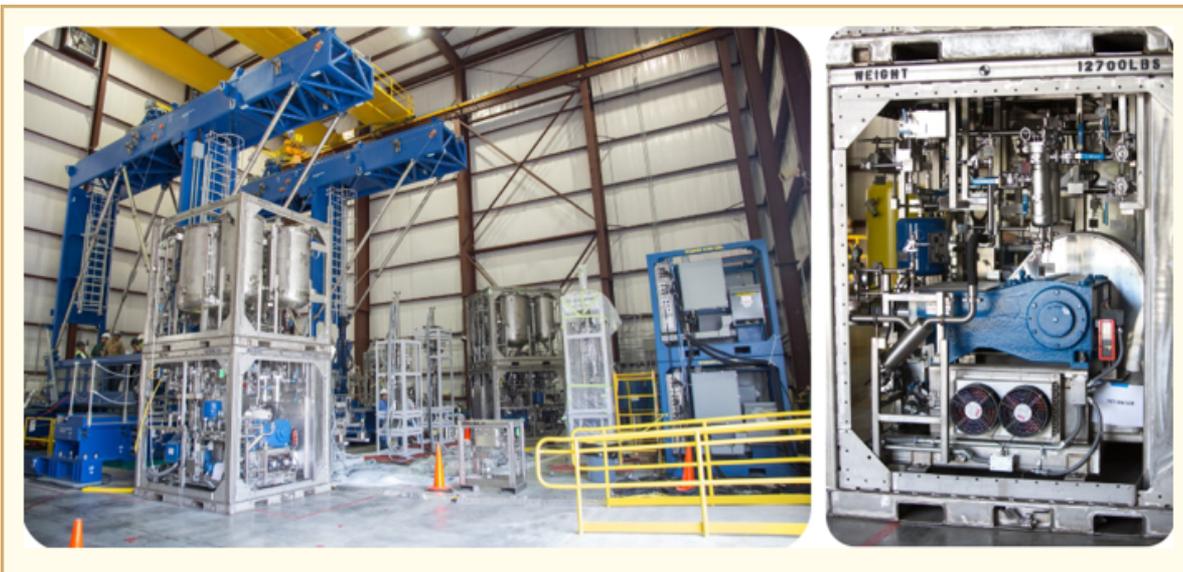
Figure 16-5: WJP equipment at the training centre [Martin, 2016].

US plants have also needs regarding potential WJP applications (Figure 16-2). Thus, Mitsubishi has developed tools for the US market (Figure 16-3). Two tools for BMNs WJP and two tools also for RVNs WJP have been fabricated. A WJP training centre has been built with BMN and RVN mock-ups (Figure 16-4) and a full size WJP equipment (Figure 16-5).

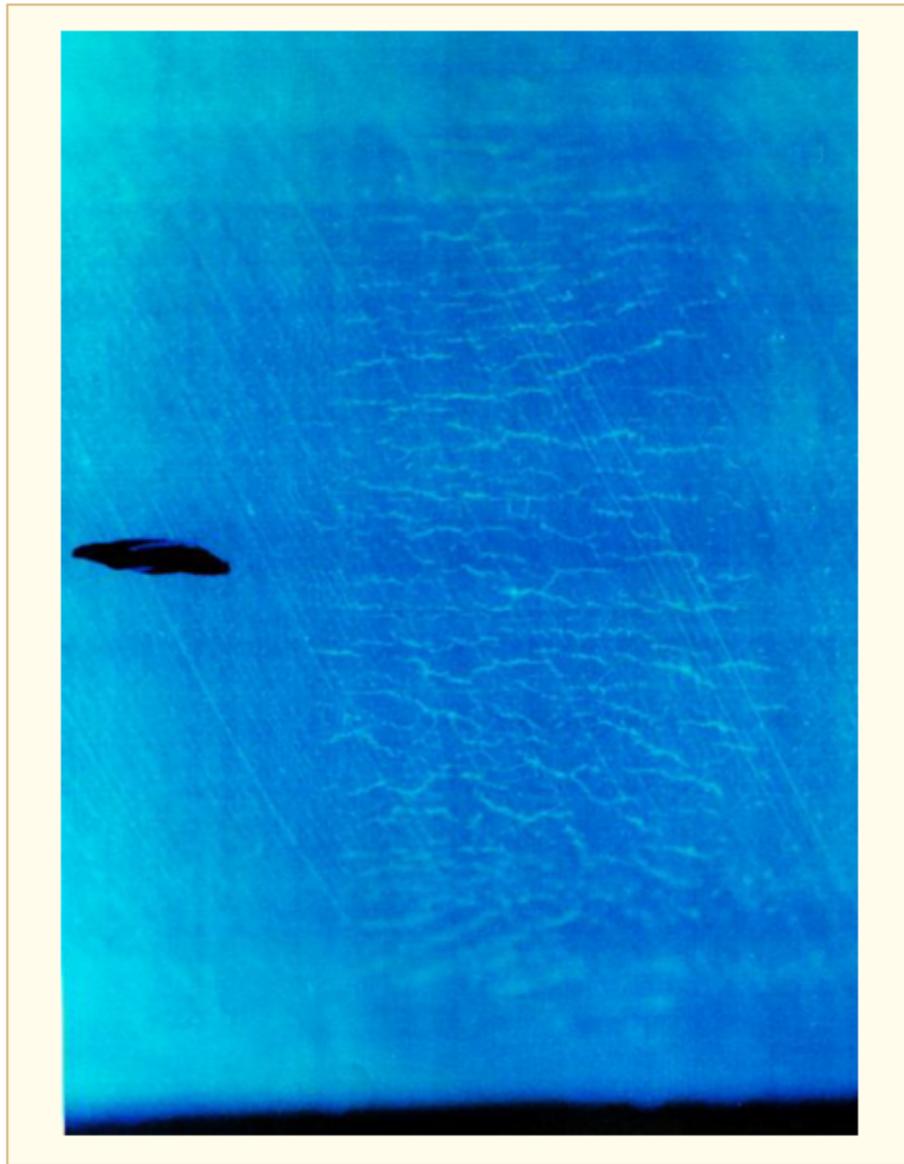
Figure 18-1: Fluorescent dye penetrant results of Ringhals Unit 2 CRDM Nozzle [Fyfitch et al., 2016].
