The condenser: a key player for a good feedwater chemistry

François Cattant

A.N.T. INTERNATIONAL®

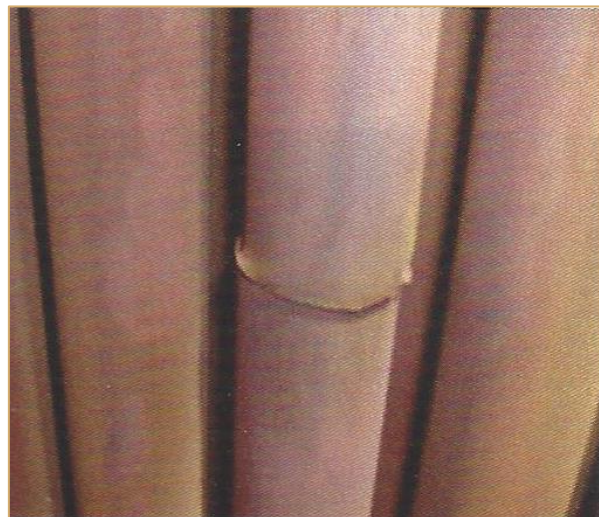
Figure 6-1 Condenser tube broken by mechanical fatigue [Hutin, 2016].

The internal structures and the tubes vibrate as a consequence of the steam flow. When the level of vibrations becomes too high, tubes can break by fatigue (Figure 6-1).

However, more commonly, adjacent tubes get into contact and wear each other until through wall wear. Installing backing bars is a good means to lock tubes in place, however, it is not the end of it as backing bars can themselves move, vibrate, be worn or break, therefore requiring inspections and/or repairs. Vibration of condenser internals such as plates or support structures can lead to their rupture and as a consequence, generate foreign objects which can wear or break tubes.

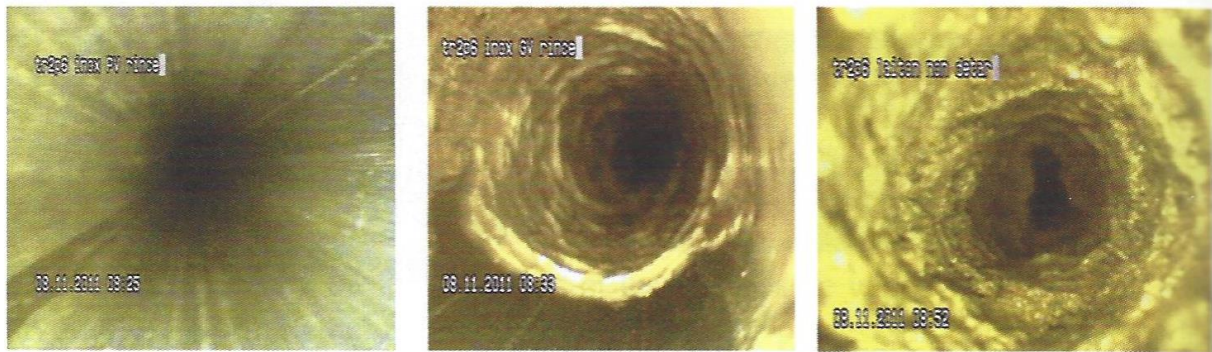
Figure 6-2 View of condenser tubes ID. Left: clean tube. Middle: tube with scale deposits. Right: tube almost plugged by deposits [Hutin, 2016].

Regarding the tubes ID, one of the main operational issues is scale deposits, especially for closed cooling systems. Scale forms by precipitation of mineral salts contained into the raw water at the ID, under the modification of physical (i.e., temperature) and chemical (i.e., concentration) conditions. Scale deposits are more or less hard and bonded to the surface and their thickness can reach one millimetre if nothing is done to prevent it (Figure 6-2).

Generally, the main constituent of scale deposits is calcium carbonate, however, other elements, more or less deleterious, can also precipitate. The consequences of scale deposits are multiple: the heat exchange between secondary /steam water and cooling water is impaired, and therefore, the condenser thermal efficiency decreases which in turns, decreases also the plant output level. Moreover, the deposits favour the concentration of harmful chemical species, thus increasing the corrosion risk of condenser materials.

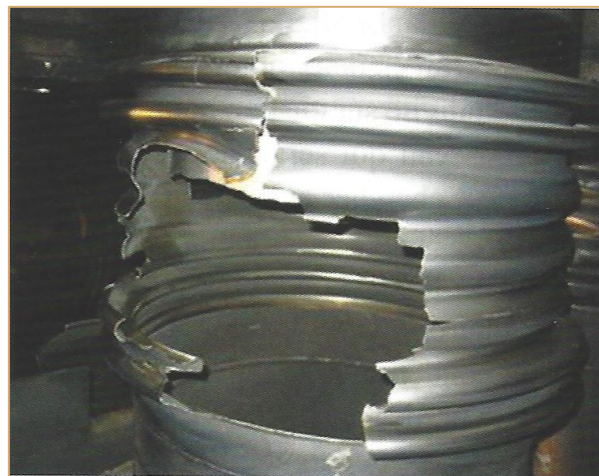
Figure 6-3 Steam extraction expansion joint, corrugated steel severely torn out [Hutin, 2016].

Steam extraction lines are typically equipped with corrugated metallic expansion joints. Some have failed, sometimes with extended tearing, along with missing sections generating loose parts (Figure 6-3).
