PWRs Operation and Maintenance

Feedwater Plant and Other Secondary Components – Mechanical Components

François Cattant

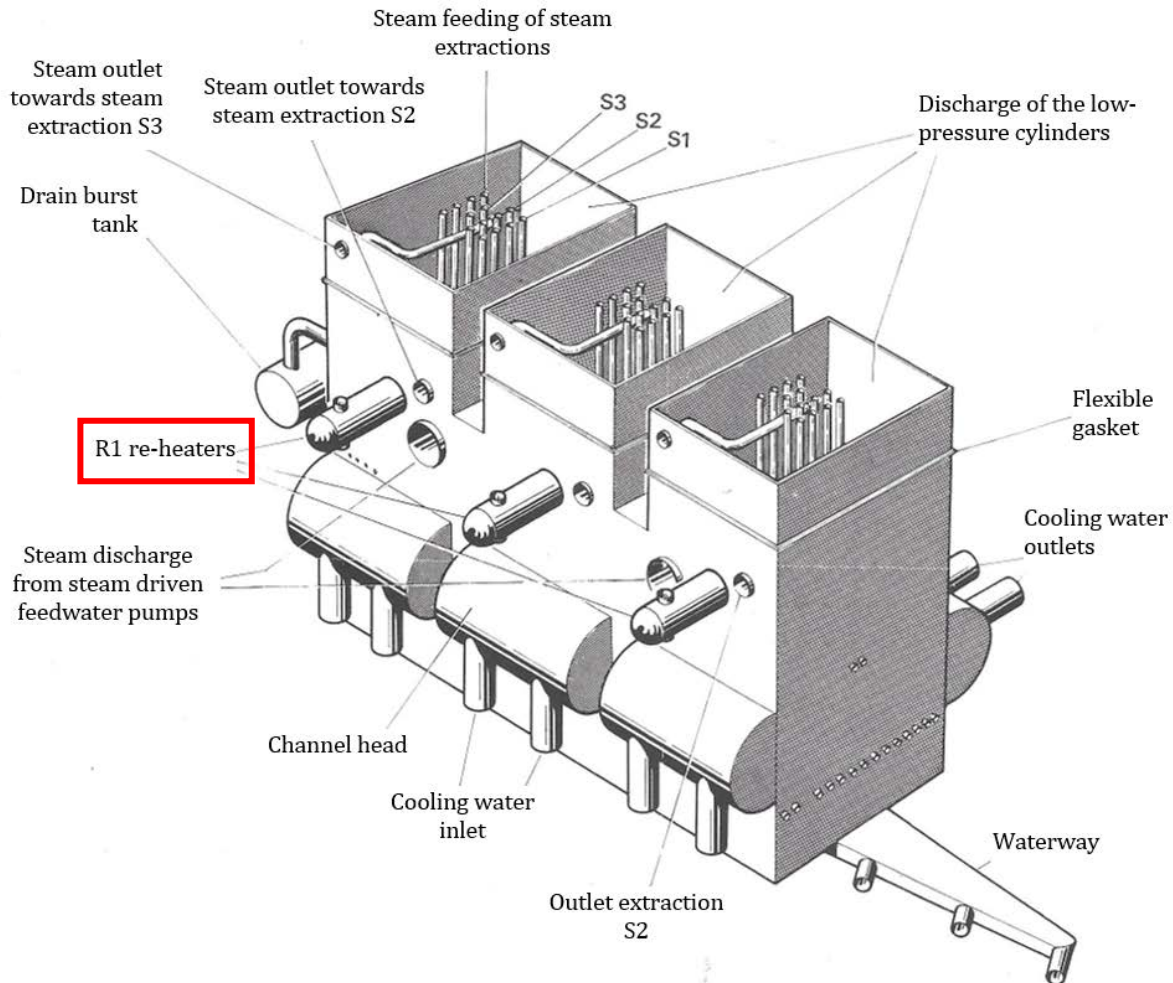
In case of a low pressure reheater leak, it is possible to separate one train to fix it; as a consequence, the output power will decrease by 15 MWe for a 900 MWe unit (or more if the remaining operating reheater of the other train has many plugged tubes). Note that if a leak occurs on the first reheater of the train, this reheater cannot be isolated steam side because it is located inside, at the top, of the condenser (Figure 4-3). As a consequence, if a reheater #1 leaks, identifying and plugging the leaking tube(s) require a plant shutdown for one or two days.

Figure 4-3: Condenser, view from the cooling water inlet side. Location of the R1 re-heaters [Cattant, 2021].

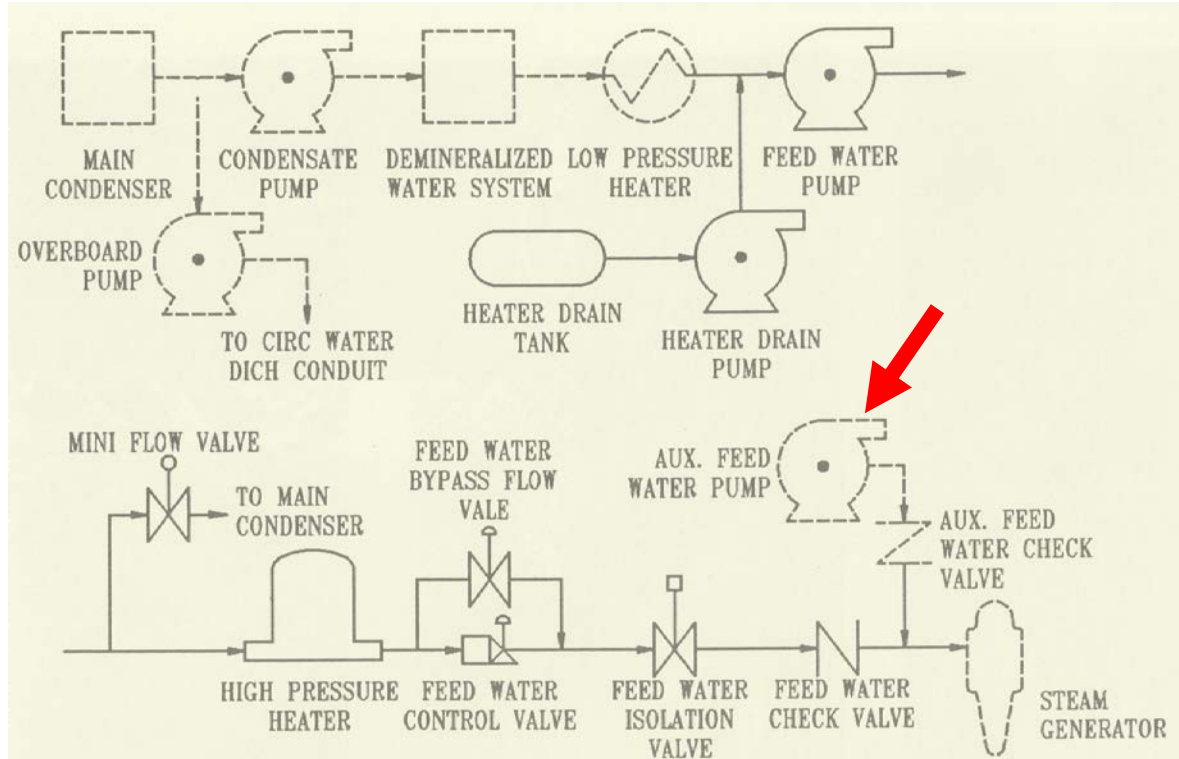
Relevant component: Steam inlet valve of turbine driven auxiliary feedwater pump. The (Figure D-5) shows the schematics of the feedwater system.

Figure D-5: Sketch of the feedwater system [Lai et al, 1990].

Specimen data: Spring of a valve of an auxiliary feedwater pump made of AISI 5160 steel (AFNOR 55Cr3). Carbon: 0.560% – 0.640%, Chromium: 0.7% – 0.9%, Manganese: 0.750% – 1%.

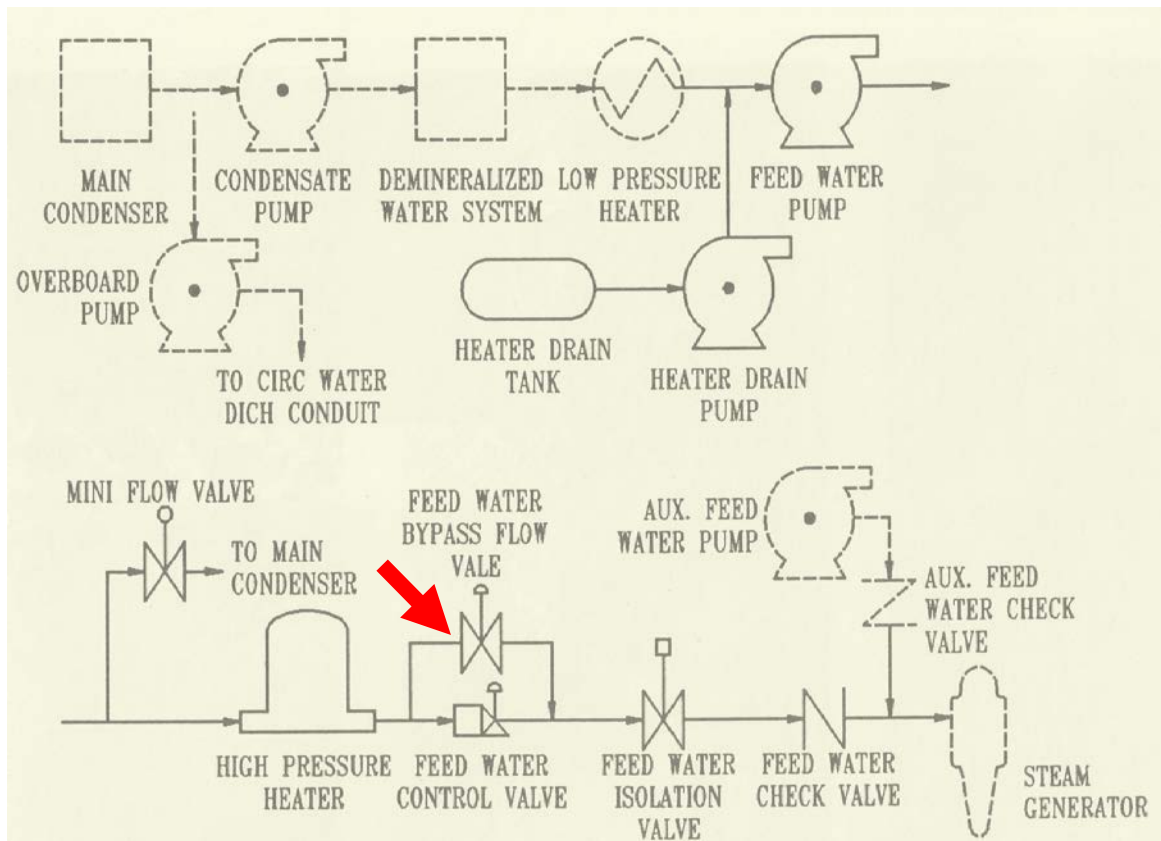
Relevant component: Feedwater bypass flow valve. The (Figure F-1) shows the schematics of the feedwater system.

Figure F-1: Sketch of the feedwater system [Lai et al, 1990].

Specimen data: Plug, made of AISI 316 austenitic stainless-steel, of the feedwater bypass flow valve.

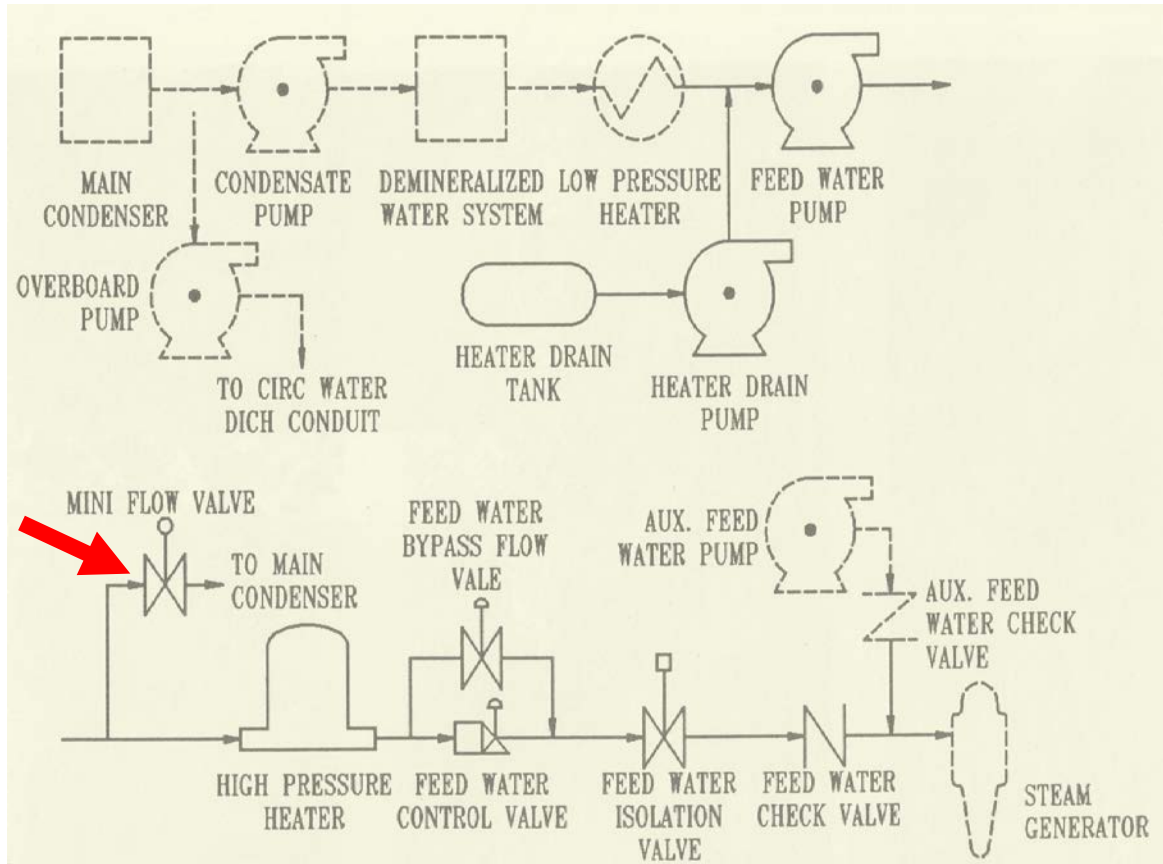
Relevant component: Mini flow valve of the feedwater plant. The (Figure F-3) shows the schematics of the feedwater system.

Figure F-3: Sketch of the feedwater system [Lai et al, 1990].

Specimen data: Casing bolts of the feedwater mini flow valve. These bolts are made of low chromium steel (0.15%).

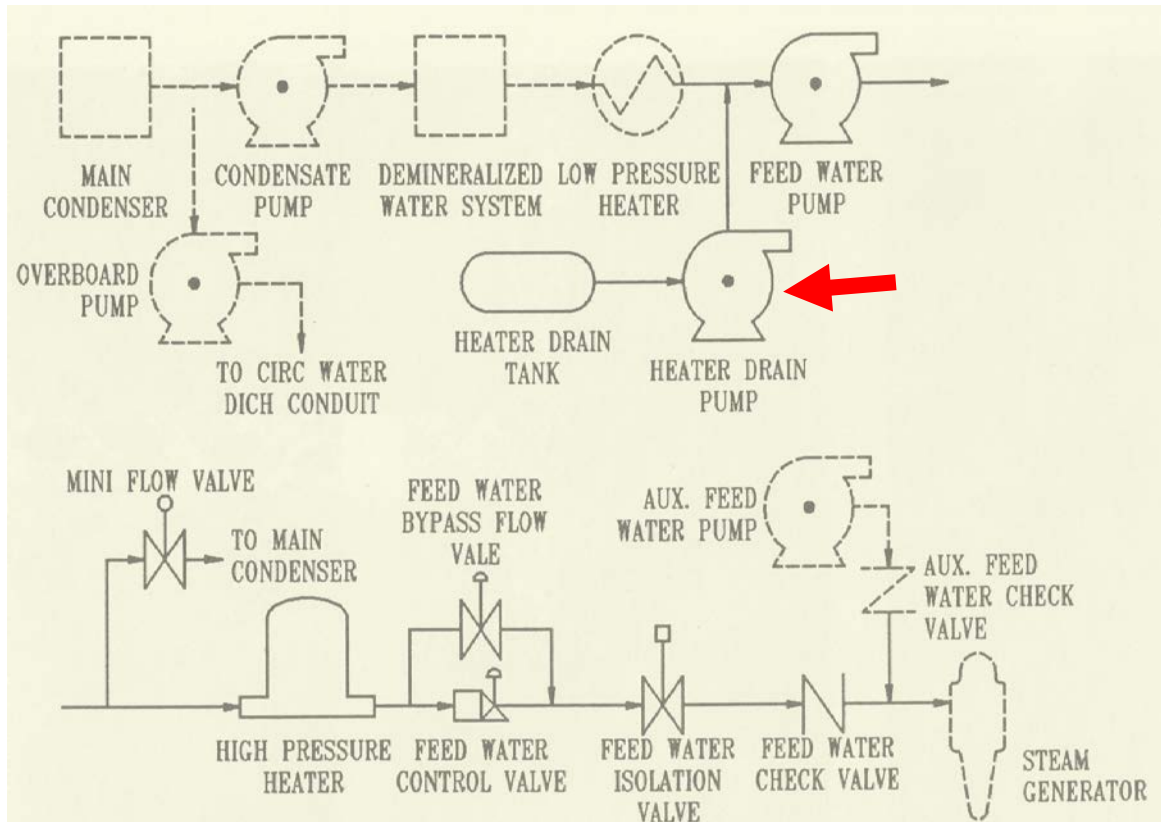
Relevant component: Heater drain pump shaft made of AISI 410 stainless-steel. The (Figure G-1) shows the schematics of the feedwater system.

Figure G-1: Sketch of the feedwater system [Lai et al, 1990].

Specimen data: The heater drain pump type used in the units is a 8-stage vertical water pump, about 10 meters high and the vertical motor power is 1,250 horse power, its rotating speed being 1,780 rpm. The pumps flow rate is 3,914 gallon per minute (890 m³/h). The water temperature is 196.6°C. The water pressure is 1.34 MPa in the suction line and 4.55 MPa in the discharge line in normal operation conditions.
